Concrete & Building in Haiti

Faith Lutheran Orphanage

Report Concerning the March 2016 Trip

Forensic Analysis of the Ceiling of the Boys' Dorm at Faith Lutheran Orphanage – March 20

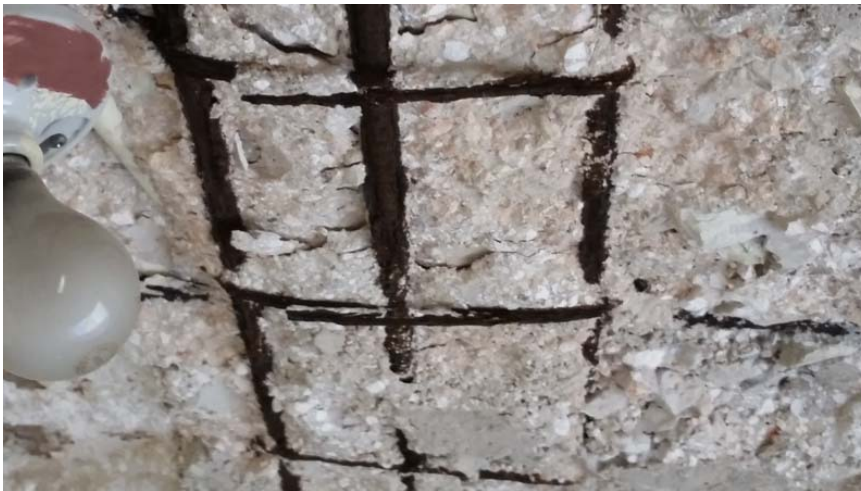
This photo is typical of areas where plaster and concrete has sloughed off from the ceiling. It shows the strong corrosion of the steel rebar. Note the cracks in the concrete above the rebar. This indicates that the cracking goes deep into the roof structure. Herb pulled some of the roof concrete off by hand and was able to crush it in his hand. He was also able to break sections of the steel rebar. There is no longer electricity reaching the bulb in the center of the room, which provides the only illumination for the room at night.

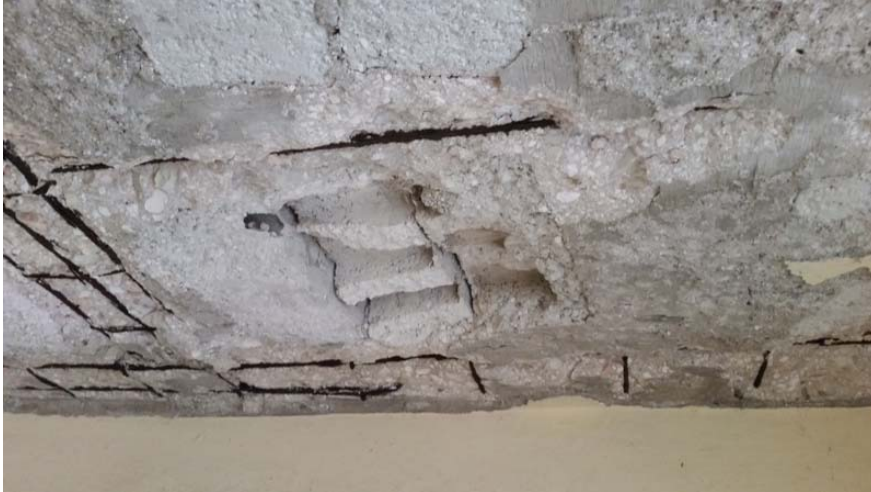
Concrete block were used as space fillers in the flat concrete roof. This is a typical construction method in Haiti. Many of the block were made with aggregate loaded with clay and were shorted on Portland cement. As a result Herb was able to remove pieces by hand and crush them by hand.

Gently poking the exposed concrete and rebar with his rubber-footed cane resulted in iron oxide and pieces of concrete falling to the floor.

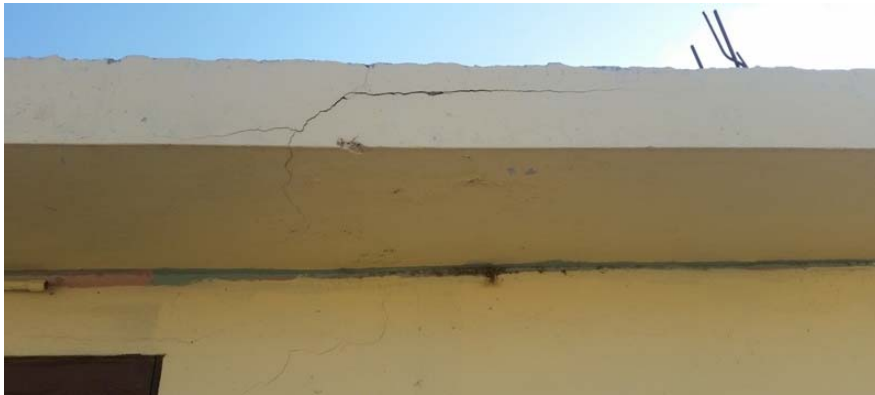
This photo shows the deterioration of the roof from the front of the building. The cracks in the edge of the roof and the underside of the roof overhang show the impact of expanded rebar. On this short overhang, there are not the stresses which develop with the longer spans which are found over the rooms, but the expanding rebar is tearing the roof apart.

Note the rebar sticking up above the roof. The plan for this building, which is common in Haiti, was to add a second story.

(3) The only way to continue to use the building for a few years would be to remove the roof and replace it with a metal roof.

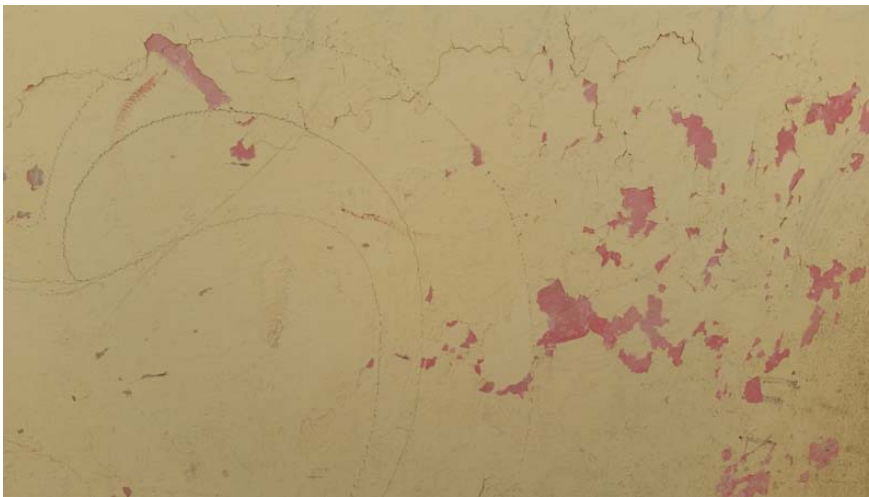
This photo shows the peeling paint on the exterior walls. This is a sign that the outer walls have a long-term moisture problem. Peeling paint was covered by paint

which peeled, which was covered by paint which peeled. There were several minor cracks in the exterior walls which indicated the corroding rebar problem had started in them.
