Concrete & Building in Haiti

Faith Lutheran Orphanage

Report Concerning the March 2016 Trip

Forensic Analysis of the Ceiling of the Boys' Dorm at Faith Lutheran Orphanage – March 20

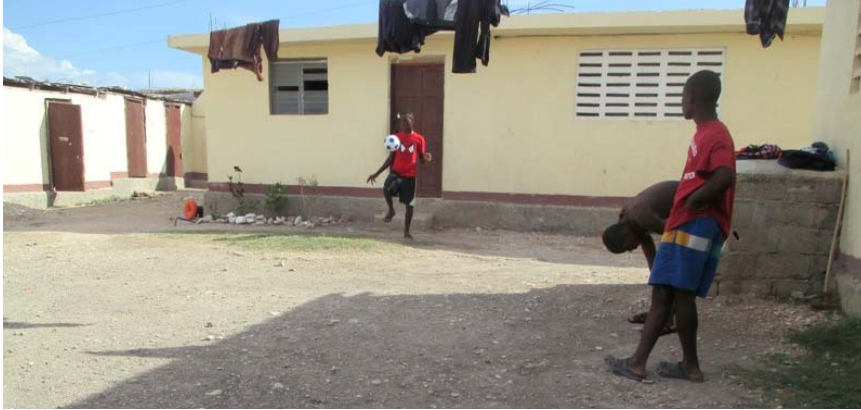
This photo shows the Southeast end of the Boys' Dorm. The buildings to the left in the photo are the latrines. The addition starts just to the right of the door that is shown in the photo. The original structure had ventilation blocks for windows. The addition has a jalousie window in front, but there are no windows on the side or the back.

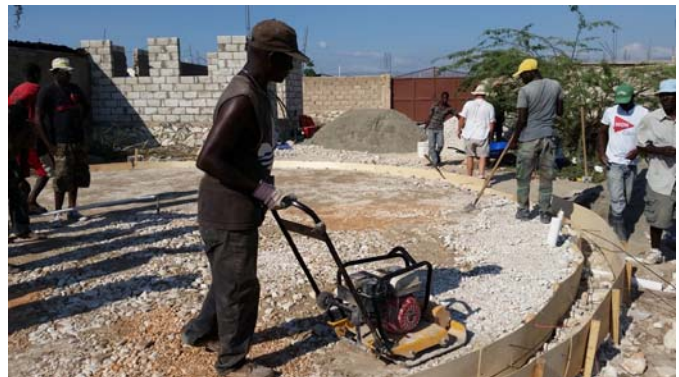
In adding base material Herb was not able to get across that we did not

need to fill with base material way beyond the top of the inner form boards. After the compacting started, there was a lot of extra work that had been done that had to be undone.

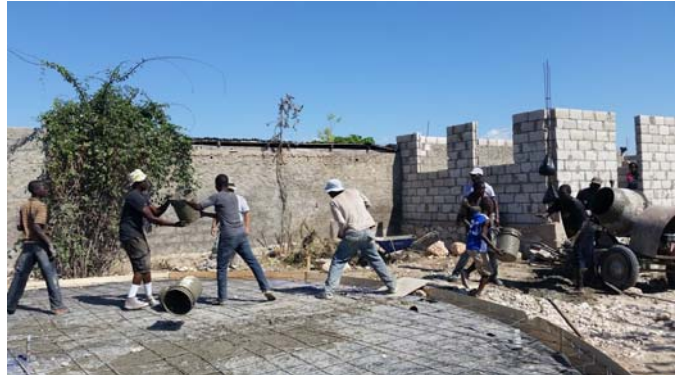
As the concrete was being placed, there tended to be a bulge between the center stake and the outer form. We tried to minimize that, but were never able to get it eliminated completely. This resulted in the concrete near the center point being 2.5 inches thick. The concrete near the outer form was 2.5 inches thick, and the concrete in between ranged from 3.5 to 4.0 inches thick. There was also an area where the inner form was low (where the outer form level had had to be adjusted), and the concrete ended up being 5 inches thick rather than the design thickness of 2.5 inches.
