Concrete & Building in Haiti

Building Homes for Jubilee Report Concerning the September, 2015 Trip

As of October 23, 2015 By: Herb Nordmeyer

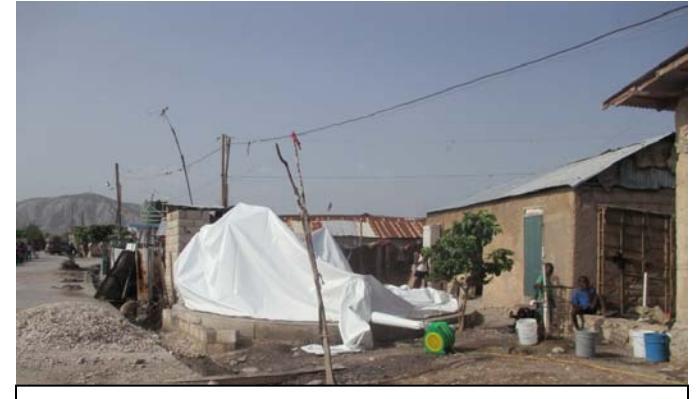
Erecting the Airform. Note the proximity to the sewer ditch, the adjacent home, and the community water well.

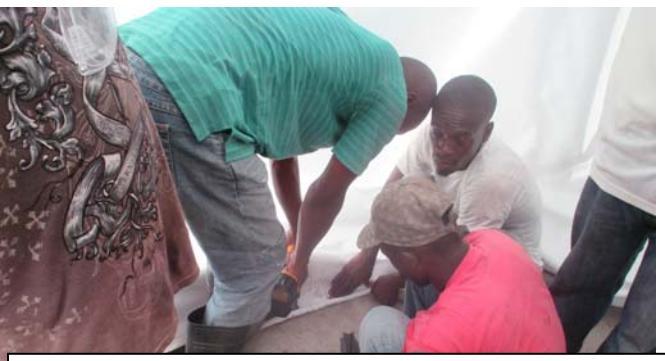
Attaching the Airform was done from the inside. Each crew member was trained to install the Airform.

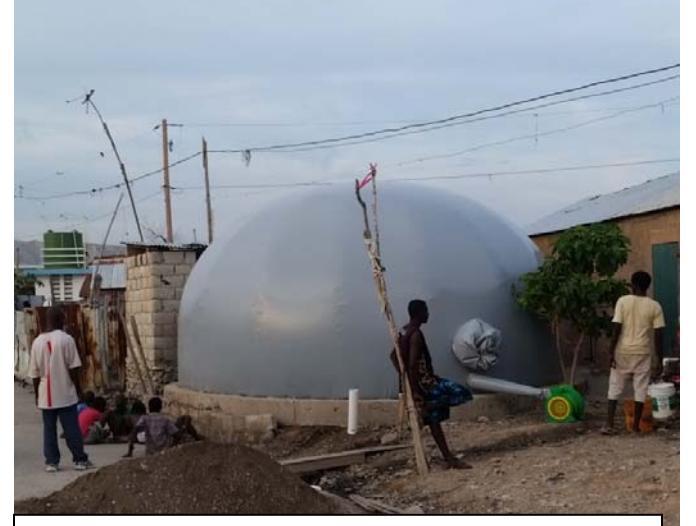
The Airform was inflated and brought up to pressure.

With the blower running, we got the pressure up to 5 inches of water. We were shooting for 6 inches, but did not quite make it. With the first of the stucco, we placed a band around the base of the Airform and that helped seal the system. After that we got the pressure up to 5.5 inches of water.

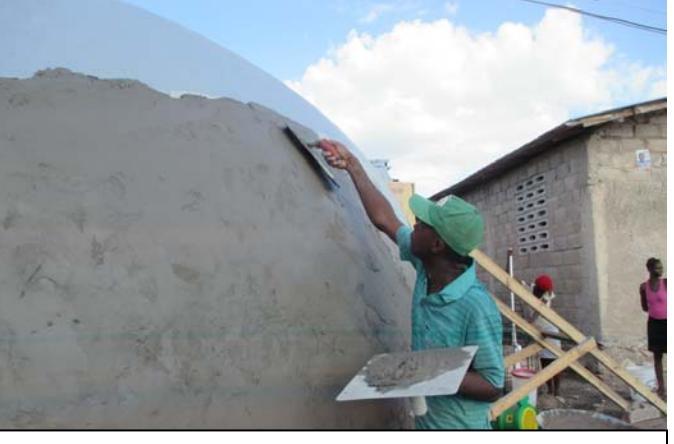
Applying the first coat of stucco.

being kept moist and with the thin coating, that skim coat cracked. The next morning the crew understood what I had been saying about a thicker coat, and they then applied the appropriate coating of stucco. When the Airform was removed, the cracks in that initial skim coat showed and they added a finishing coat on the inside.

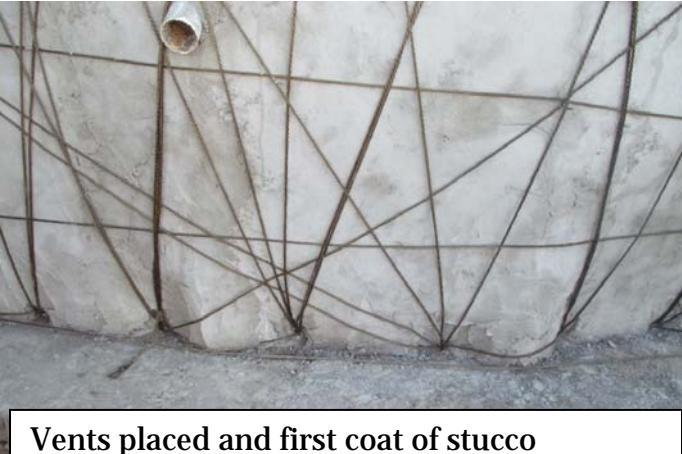
Vents placed and first coat of stucco wrapped with basalt rope.

After the first full coat was dry to touch. the dome was wrapped horizontally, vertically, and at about a 45 degree angle with basalt rope. To make the wrapping easier and to do it without having to get on the roof, the rope was passed through a section of 1 inch PVC pipe. That way a person could stand on the ground and accurately place the rope. The pipe used was Schedule 20, and it was more flexible than desired. Schedule 40

By the time the rope was in place and the first coat of stucco had cured, there were cracks showing in the stucco. This was to be expected. The number and extent of the cracks

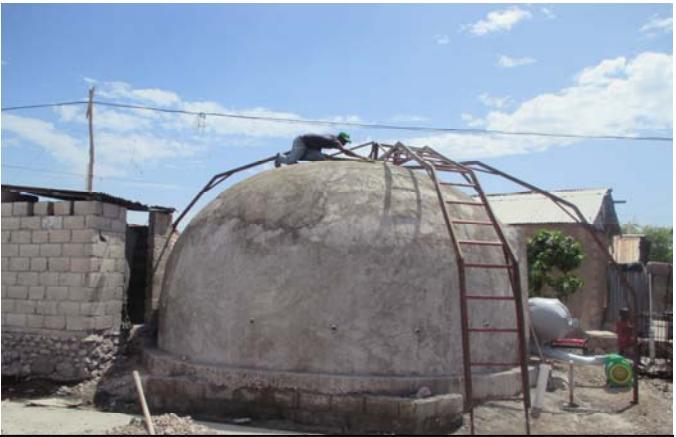
Applying the third coat of stucco.

After curing overnight, the third coat of stucco was applied. While we planned on using 1.5 inches of stucco, we used 2.5 to 3.0 inches over most of the dome. Since there were some problems with the stucco, which are reported in the next section, I was not adverse to having extra stucco on the dome.
